TOWN OF HUDSON

Conservation Commission

Subject: Environmental Issues Regarding the Conceptual Circumferential Roadway

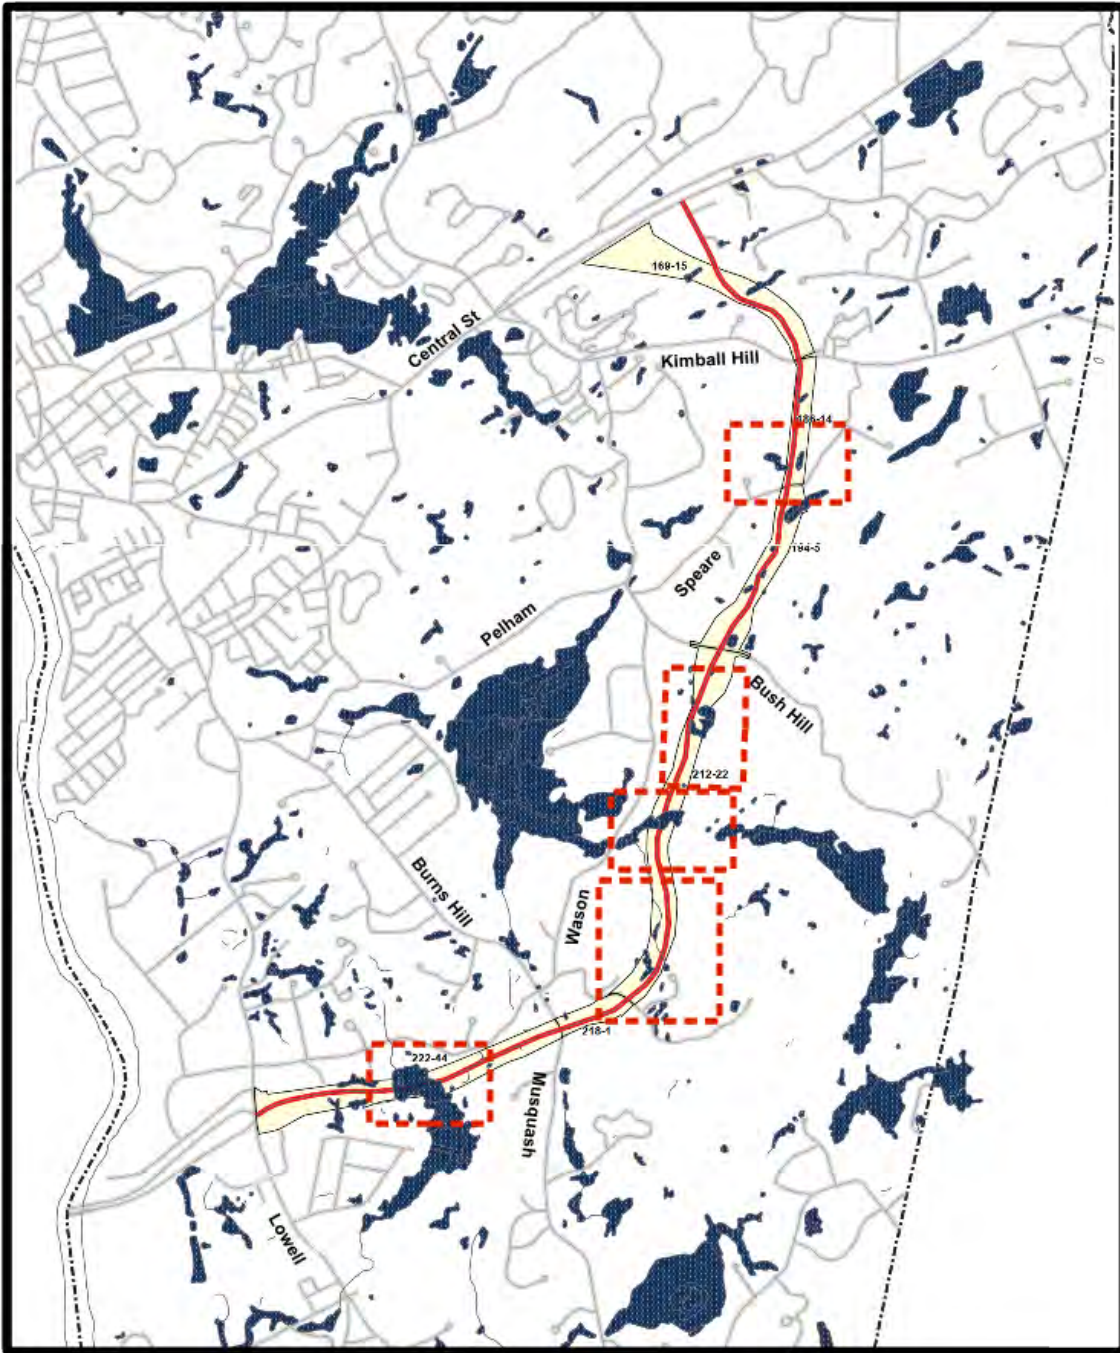
Attachment 1 – Conceptual route for circumferential roadway (red line) as defined in the CTAP Hudson Discret Project Report (Oct 2009) with the existing Nashua-Hudson Circumferential Highway right-of-way (yellow areas). Blue areas are US Fish and Wildlife National Wetland Inventory wetlands in Hudson. Red dashed boxes indicate areas discussed in this memo.

2. The conceptual roadway layout was restricted to the existing Nashua-Hudson Circumferential Highway (NHCH) right-of-way. The route was selected to minimize wetland impacts based on existing GIS mapping and aerial photography available to the NRPC (Attachment 1). This concept assumed that reducing the width of the roadway to two lanes, in contrast to the proposed multilane NHCH highway, many of the adverse environmental effects that resulted in the cancellation of the NHCH project could be reduced or avoided.

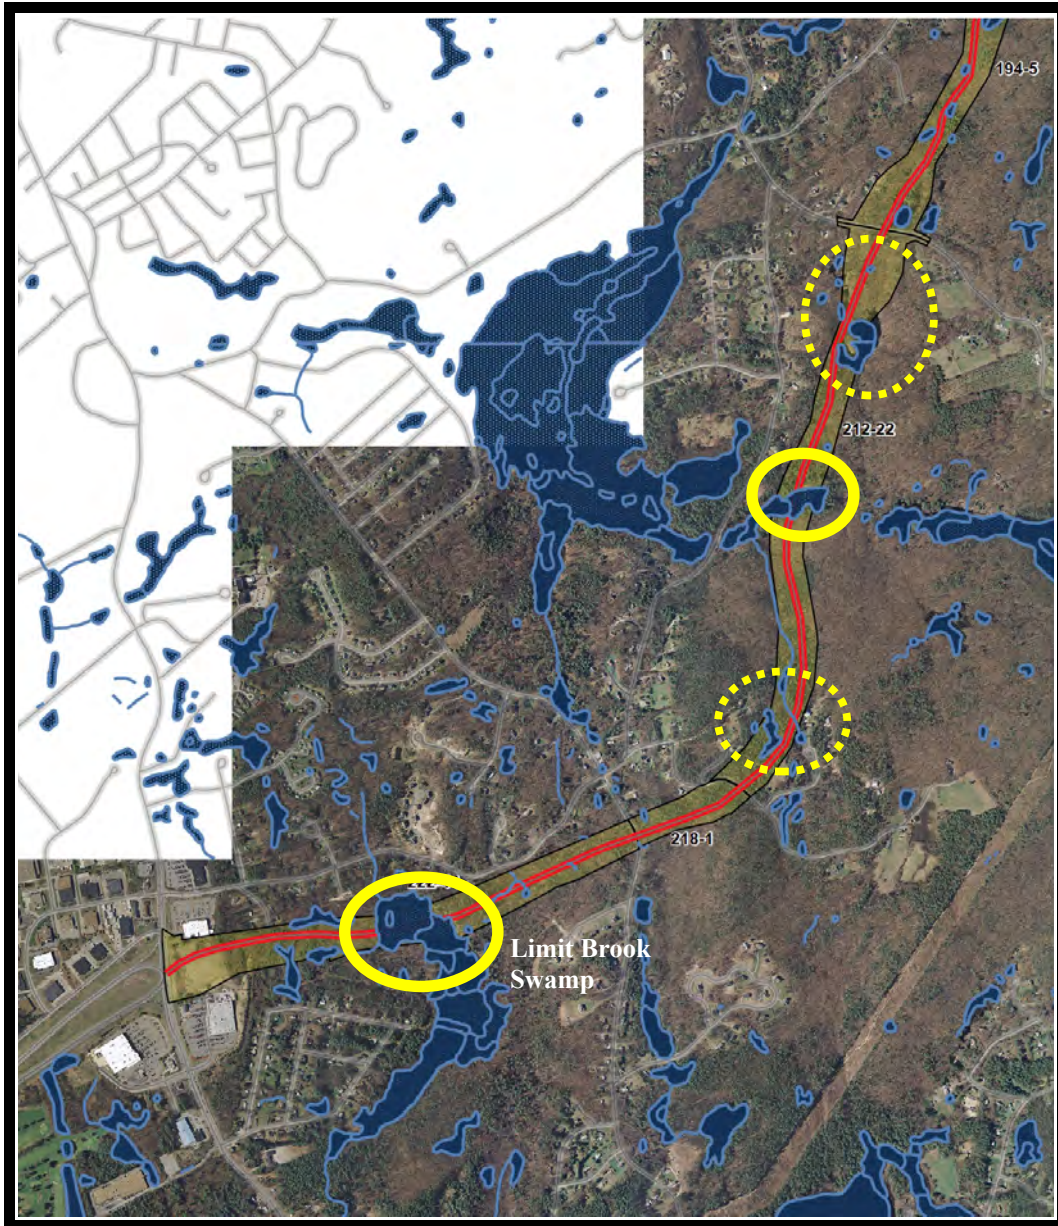
Attachment 2 – Plot showing NWI wetlands on 2010 aerial photos showing the Limit Brook and Miles Swamp wetlands crossings (solid yellow ovals). Both wetlands are considered to have relatively high functional value. Two other potential significant wetland impact areas are highlighted in dashed yellow ovals.

5. Of particular note are the proposed crossings of Limit Brook Swamp and Miles Swamp (Attachment 2) both of which were identified as having significant functional value during the Prime Wetlands Assessment conducted in 2008 for the Hudson Conservation Commission. This evaluation was made using a scientifically defensible process know as the *Method for Comparative Evaluation of Nontidal Wetlands in New Hampshire* (Ammann and Stone, 1991). These two wetlands had functionality rated as in the upper half of the 28 major Hudson wetlands examined in this study.

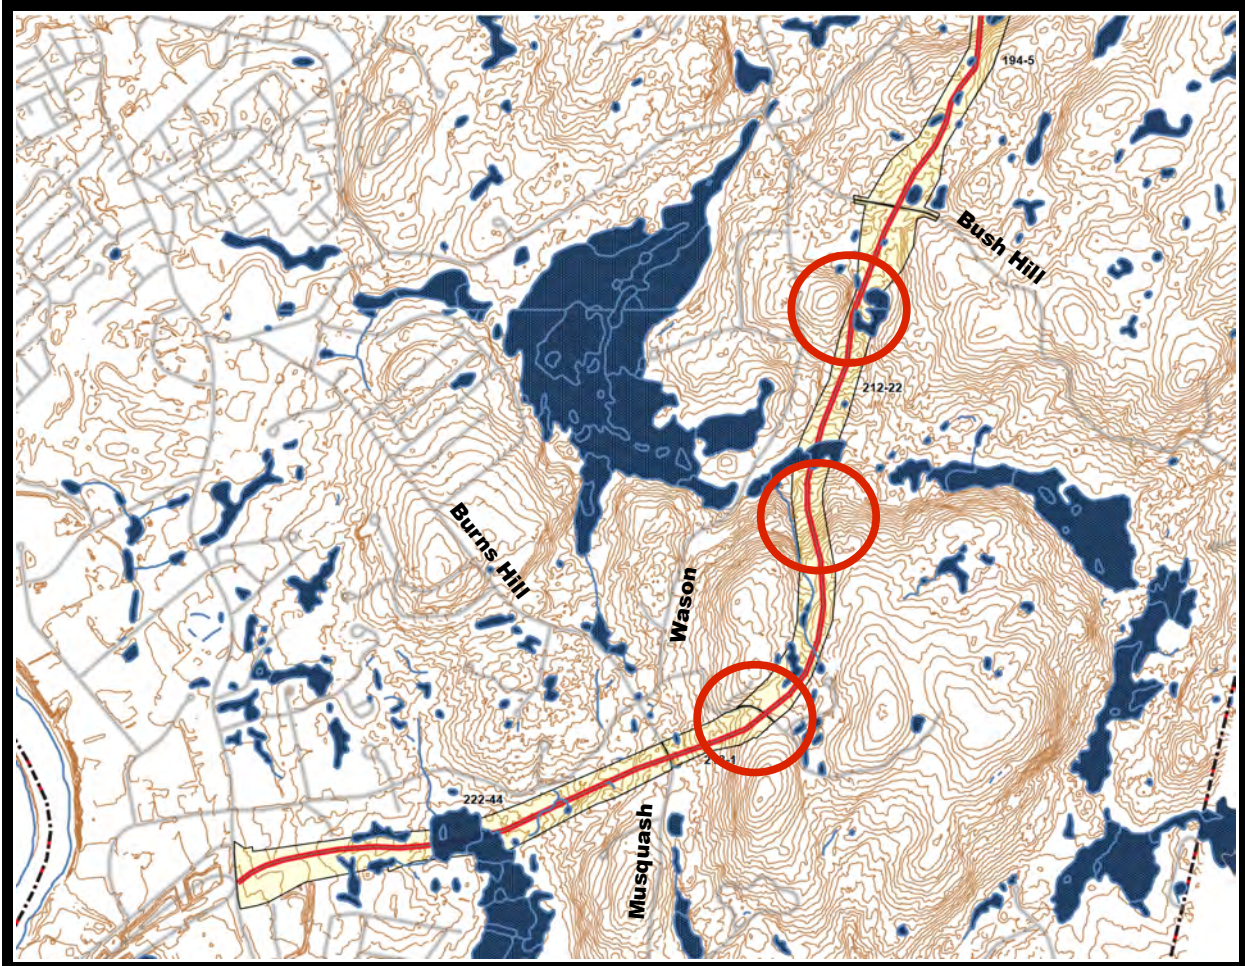
Attachment 3 – Topographic contours underlying the conceptual route of a circumferential roadway (red line) highlighting (red ovals) several areas which might require terrain alteration during construction that could have potential impacts on wetlands and streams.

6. The Commission noted several areas of steep slopes in this segment of the right-of-way

whose modification for roadway construction would result in alteration of terrain also likely to produce adverse drainage and wetland impacts (Attachment 3).

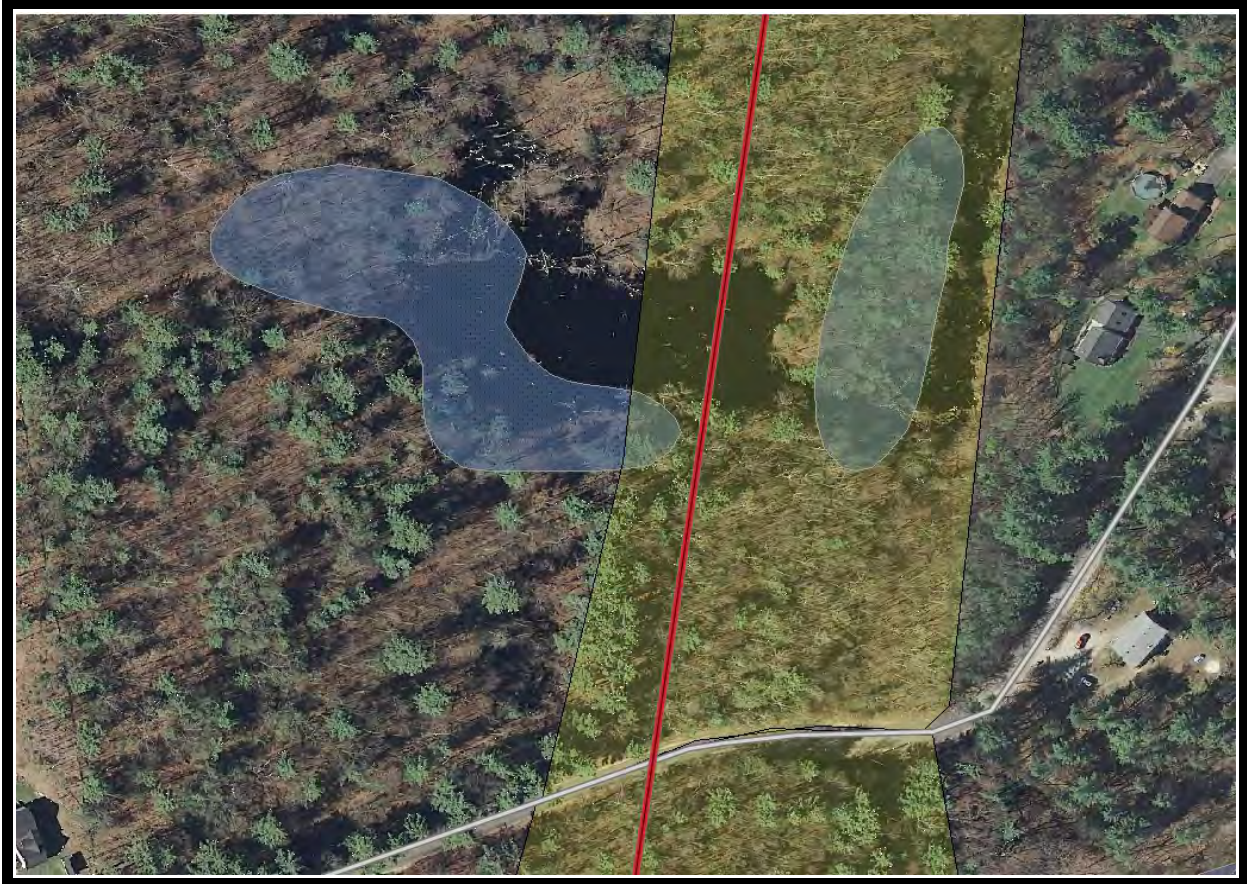
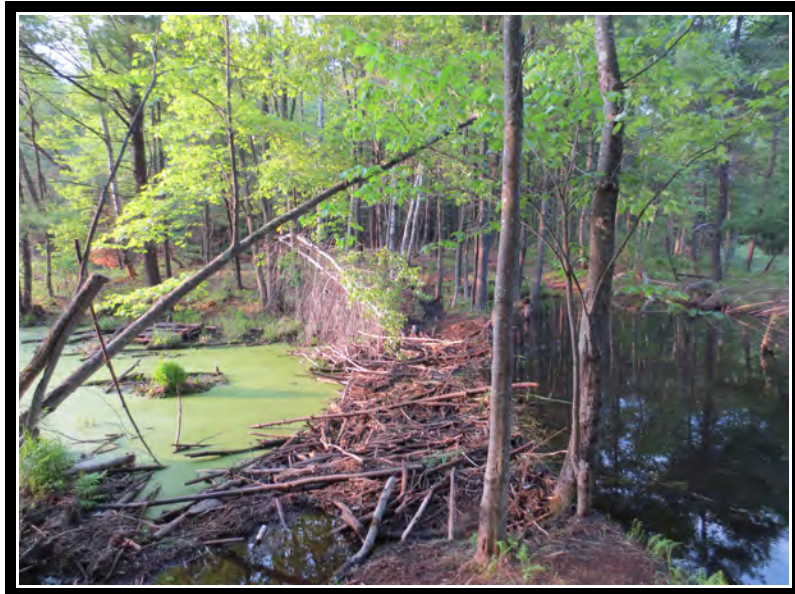
Attachment 4 – Figure A compares the National Wetland Inventory (NWI) wetlands (blue shapes) near Speare Road (gray road at bottom of figure) as compared to a 2010 aerial photo of the same area showing more extensive wetland development. (Misregistration of the wetlands is likely due to the scale of mapping used for the NWI). The NHCH corridor is defined by the yellow overlays and the proposed roadway by the near vertical red line. Note that the roadway appears to stay out of the wetlands as defined by the NWI while it passes through the wetlands in the photo. The second photo (B) shows the only dry land between the two wetland bodies north of Speare Road is a small dam.

7. Of concern for the proposed routing is the fact that the existing mapped wetlands throughout the corridor is deficient and does not accurately represent the on-the-ground situation. This possibility is acknowledged in the CTAP Report. One significant example of this mapping deficiency and its possible effect on design can be seen at a wetland pocket located in the corridor to the north of Speare Road is illustrated in Attachment 4. Minor impact is suggested by the CTAP Report but ground recognizance suggests a more significant effect. Obviously, in this case and others, further study by certified wetland scientists is required.

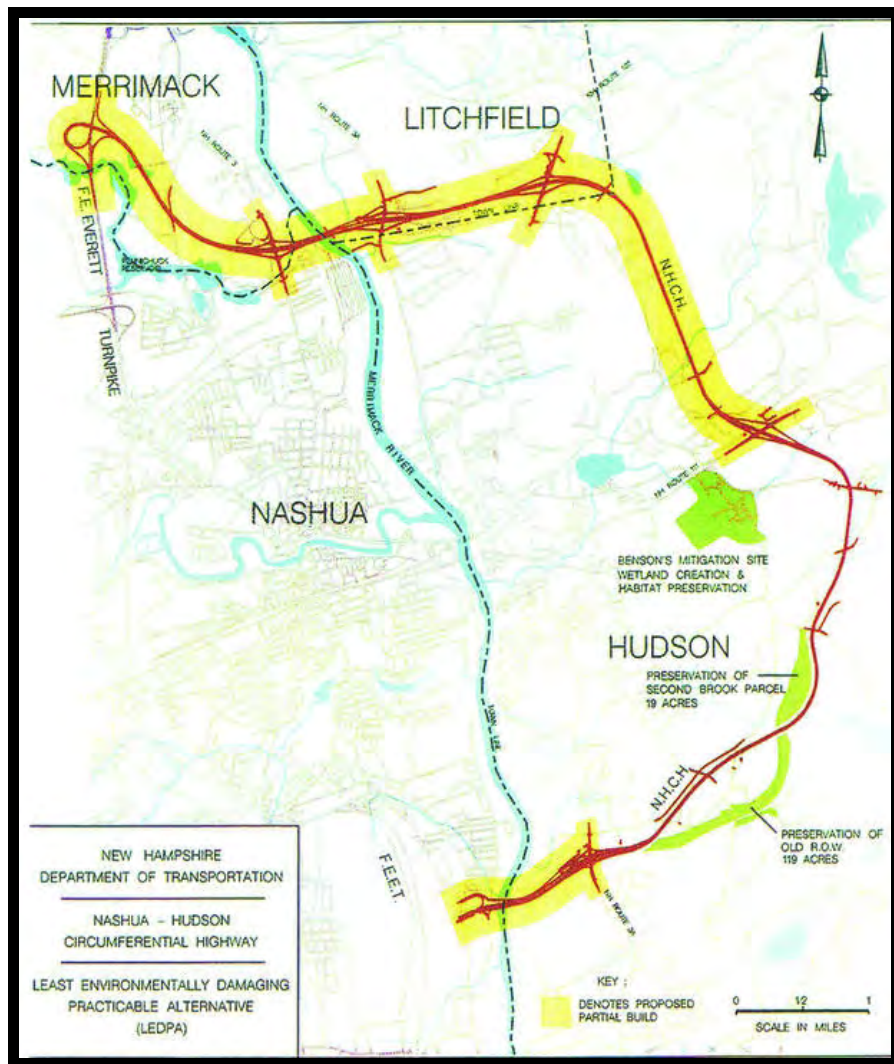
Attachment 5 - NH DoT Proposed NHCH route showing the “Least Environmentally Damaging Practical Alternative” (in red) and showing the existing corridor land that would not be used in construction to minimize environmental damage (in green). This appears to correspond to the areas highlighted as environmentally sensitive by the Conservation Commission. (Source: Ober, Lynn, “Will the Circumferential Highway Rise from the Ashes?”, **Hudson - Litchfield News**, 24.15 (2013))

9. The Commission noted that news reports, particularly the Hudson-Litchfield News (18 October 2013), suggest the possible reconsideration of the full four lane design of the HNCH. In that event, we believe that the proposed roadway would face the same issues as the original NHCH and would require significant rerouting outside the existing corridor particularly in the southern half of the route. This situation is clearly echoed in the New Hampshire Department of Transportation NHCH routing map accompanying the Hudson Litchfield News article of 18 October 2013 (Attachment 5).
